**Flood Control Project Maintenance  
Levee Inspections**  
**LMA District Cover Sheet**  
**Spring 2017 Levee Inspection Results**

**Reclamation District No. 0524 Middle Roberts Island**

**Spring 2017 Levee Inspection Results**

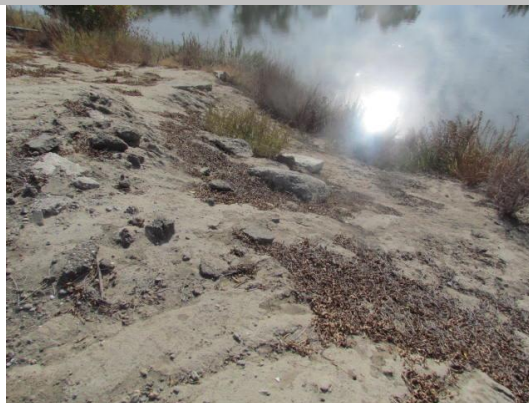
Photo 1 of 1 : SP\_2017\_RD0524\_107\_36\_20170316\_00067.jpg

LM Start	2.44	Rating **	M	Issue No.	36
LM End	2.47	Issue Type +	Ma	Location *	WS
Category	Earthen Levee			GPS Latitude/Longitude	
				Start	End
Item	Erosion / Bank Caving			37.918628 °	37.918438 °
				-121.320817 °	-121.321452 °
DWR ID	DWR_RD0524_01_s_2012_36				
Comment Code					
E1 : Note and monitor erosion site.					
Inspector Comment

Looking east at erosion on waterside slope.

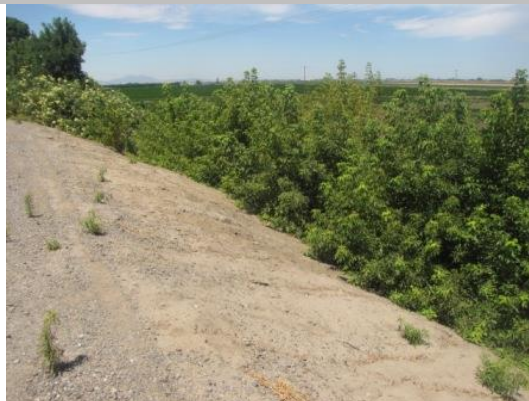
Photo 4 of 4 : SP\_2017\_RD0524\_107\_37\_20170316\_00071.jpg

Looking southwest at trees along levee landside toe.

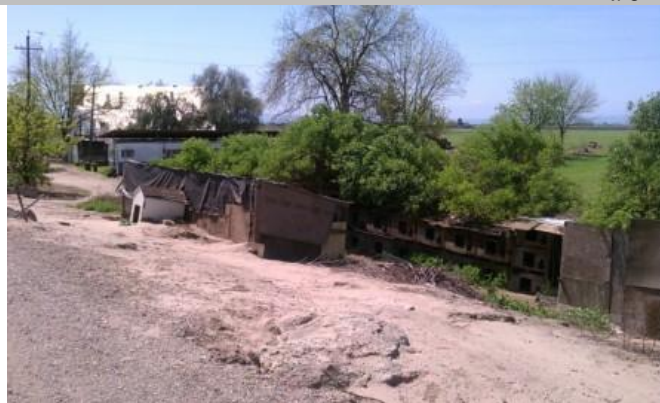
Photo 2 of 2 : SP\_2017\_RD0524\_107\_42\_20170316\_00079.jpg

Looking at animal pens on landside slope and toe.

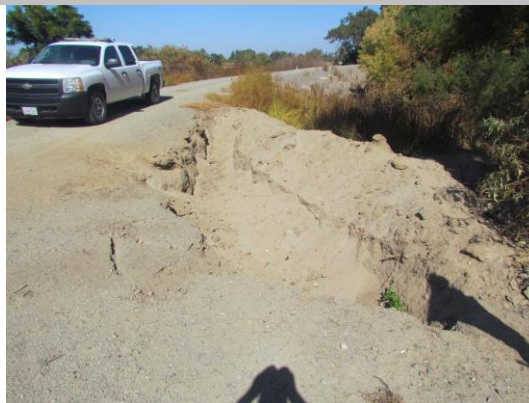
Photo 2 of 3 : SP\_2017\_RD0524\_107\_218\_20170316\_00256.jpg

LM Start	2.57	Rating **	U	Issue No.	218 (cont)	
LM End	2.57	Issue Type +	Ma	Location *	WS	
Category	Earthen Levee			GPS Latitude/Longitude		
				Start		End
Item	Erosion / Bank Caving			37.917492 °		37.917492 °
				-121.322795 °		-121.322795 °
DWR ID	DWR_RD0524_01_f_2016_218					
Comment Code						
E2 : Schedule repair of erosion site prior to the next inspection.						
Inspector Comment						
Large trench on waterward shoulder and slope. Trench is 45 x 15 x 5.

Looking northwest at trench on waterward shoulder.

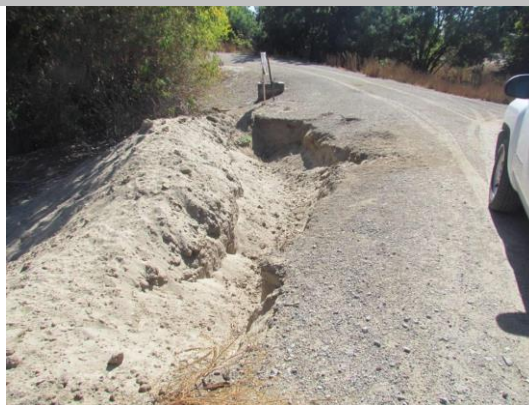
Photo 3 of 3 : SP\_2017\_RD0524\_107\_218\_20170316\_00257.jpg

LM Start	<b>2.57</b>	Rating **	U	Issue No.	<b>218 (cont)</b>
LM End	<b>2.57</b>	Issue Type +	Ma	Location *	WS

Looking south at trench on waterward shoulder.

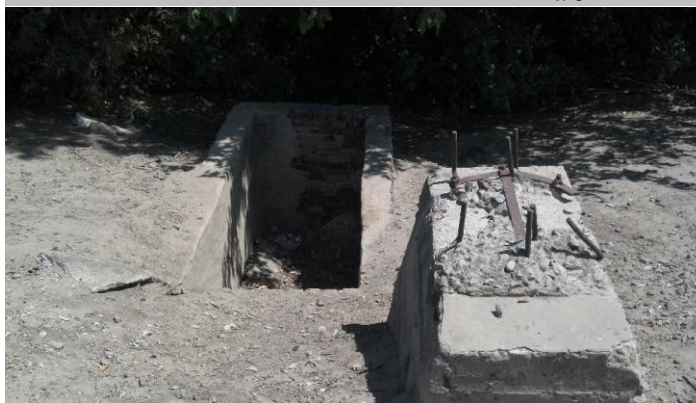
Photo 1 of 3 : UCIP\_SP\_2017\_21935\_37162.jpg

LM Start	2.58	Rating **	M	Issue No.	950
LM End	2.58	Issue Type +	En	Location *	WS
Category	Supplemental			GPS Latitude/Longitude	
				Start	End
Item	DWR UCIP Field Study			37.917365 °	37.917365 °
				-121.322779 °	-121.322779 °
DWR ID					
Comment Code					
Inspector Comment					
FS_ID:21935 DS_ID:24040 EP_NO: N/A Repair Type: Non-Urgent Crossing Status: Found UCIP Comments: Need to determine type of abandonment for pipe at this location. FIELD_STRUCT_DESC: *ABANDONED* Pump pad on LS shoulder with 4'X9' brick distribution box on WS slope. No pipe visible. 4'X9' brick distribution box on LS toe. FS Date: 8/20/2013

Foundation for pump with distribution box on WS shoulder.

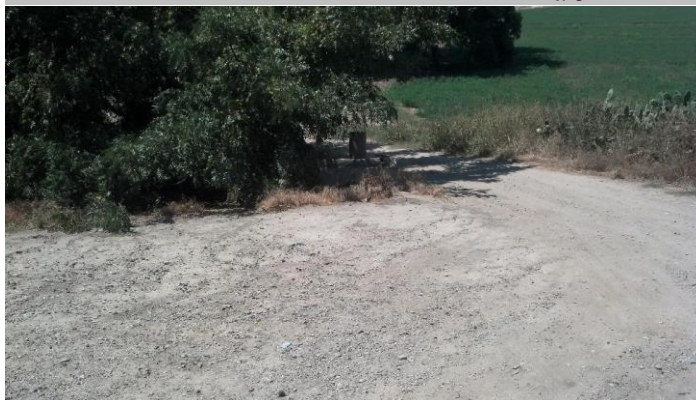
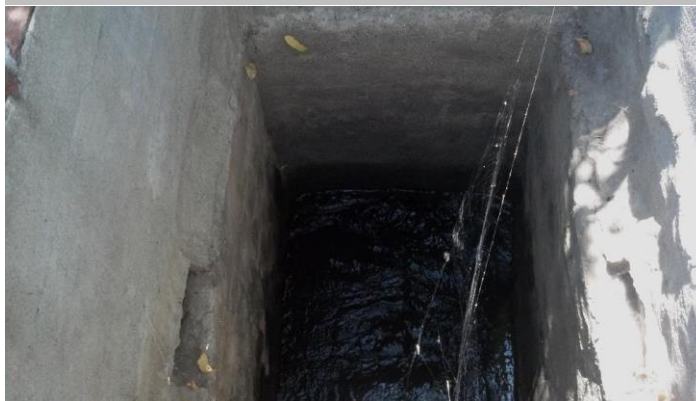
FS\_ID:21935  
DS\_ID:24040  
EP\_NO: N/A  
Repair Type: Non-Urgent  
Crossing Status: Found  
UCIP Comments: Need to determine type of abandonment for pipe at this location.  
FIELD\_STRUCT\_DESC: \*ABANDONED\* Pump pad on LS shoulder with 4'X9' brick distribution box on WS slope. No pipe visible. 4'X9' brick distribution box on LS toe.  
FS Date: 8/20/2013

LM Start	<b>2.58</b>	Rating **	M	Issue No.	<b>950 (cont)</b>
LM End	<b>2.58</b>	Issue Type +	En	Location *	WS

Distribution box on LS toe.

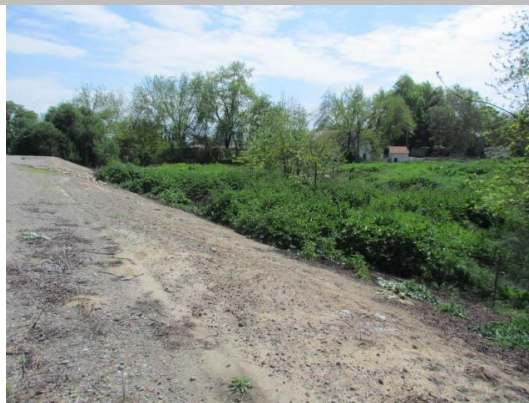
Photo 1 of 1 : SP\_2017\_RD0524\_107\_9\_20170316\_00016.jpg

LM Start	2.59	Rating **	U	Issue No.	9
LM End	2.63	Issue Type +	Ma	Location *	LS
Category	Earthen Levee			GPS Latitude/Longitude	
				Start	End
Item	Vegetation			37.917228 °	37.916858 °
				-121.322730 °	-121.322168 °
DWR ID	DWR_RD0524_01_s_2012_9				
Comment Code					
V2 : Remove the wild growth other than native grasses from the levee slopes.					
Inspector Comment

Looking southwest at dense veg at landward toe.

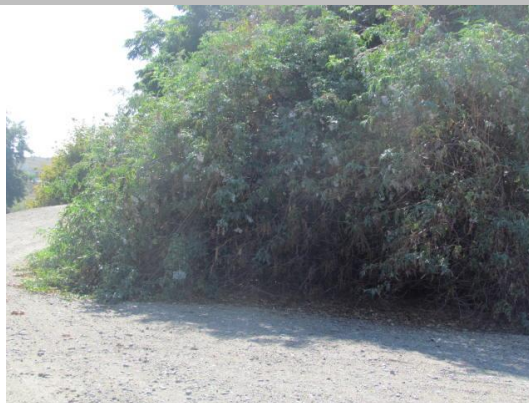
Photo 1 of 1 : SP\_2017\_RD0524\_107\_43\_20170316\_00080.jpg

LM Start	2.64	Rating **	U	Issue No.	43
LM End	2.64	Issue Type +	Ma	Location *	LS
Category	Earthen Levee			GPS Latitude/Longitude	
				Start	End
Item	Vegetation			37.916780 °	37.916780 °
				-121.322095 °	-121.322095 °
DWR ID	DWR_RD0524_01_s_2012_43				
Comment Code					
V4 : Elderberries are blocking visibility and flood fight capability.					
Inspector Comment					
Dense elderberry on landward shoulder, slope, and toe.

Looking southeast at dense veg on landward slope and toe fall 2015.

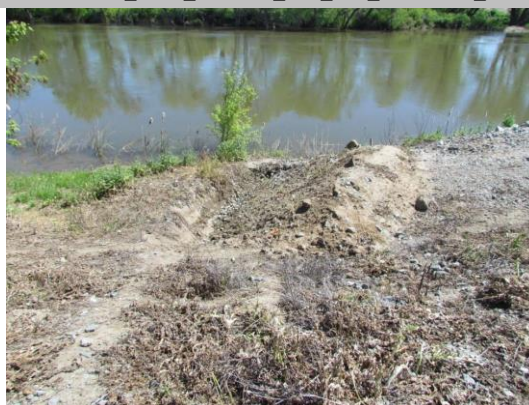
Photo 1 of 2 : SP\_2017\_RD0524\_107\_920\_20170407\_00387.jpg

LM Start	2.65	Rating **	U	Issue No.	920
LM End	2.65	Issue Type +	En	Location *	WS
Category	Earthen Levee			GPS Latitude/Longitude	
				Start	End
Item	Encroachments			37.916698 °	37.916698 °
				-121.322007 °	-121.322007 °
DWR ID	DWR_RD0524_01_s_2012_920				
Comment Code					
RA : Ramp					
Inspector Comment					
Hole dug at base of ramp on river side.

Looking east at hole at the end of ramp on waterward slope.

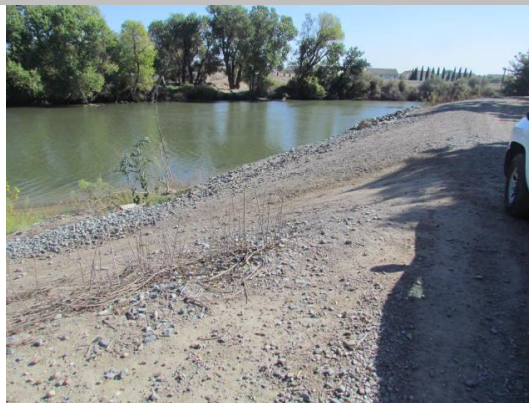
Photo 2 of 2 : SP\_2017\_RD0524\_107\_920\_20170316\_00278.jpg

LM Start	<b>2.65</b>	Rating **	U	Issue No.	<b>920 (cont)</b>
LM End	<b>2.65</b>	Issue Type +	En	Location *	WS

Looking southeast at unauthorized ramp on waterside slope. (Spring 2016)

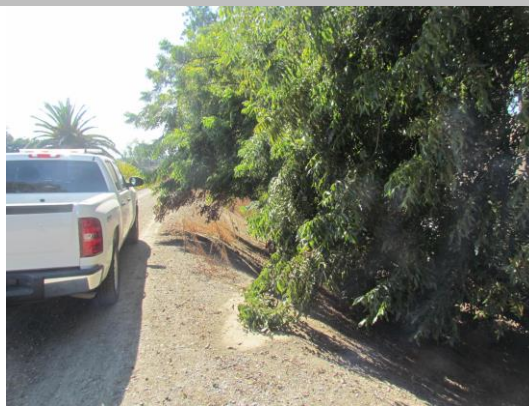
Photo 1 of 1 : SP\_2017\_RD0524\_107\_264\_20170316\_00266.jpg

LM Start	2.70	Rating **	U	Issue No.	264
LM End	2.74	Issue Type +	Ma	Location *	LS
Category	Earthen Levee			GPS Latitude/Longitude	
				Start	End
Item	Trim / Thin Trees			37.915968 °	37.915557 °
				-121.322275 °	-121.322607 °
DWR ID	DWR_RD0524_01_s_2012_264				
Comment Code					
T2 : Thin trees to allow visibility of the ground and room to flood fight.					
Inspector Comment					
Untrimmed trees along landward slope and toe.

Looking south at untrimmed trees on landward slope.

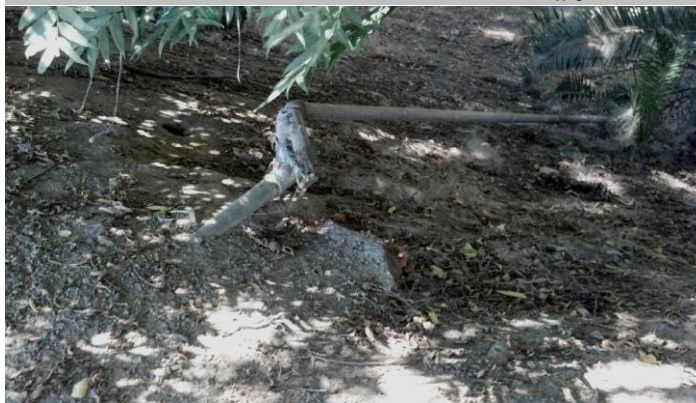
Photo 1 of 2 : UCIP\_SP\_2017\_18085\_30191.jpg

LM Start	2.73	Rating **	M	Issue No.	951
LM End	2.73	Issue Type +	En	Location *	LS
Category	Supplemental			GPS Latitude/Longitude	
				Start	End
Item	DWR UCIP Field Study			37.915698 °	37.915698 °
				-121.322501 °	-121.322501 °
DWR ID					
Comment Code					
Inspector Comment					
FS_ID:18085 DS_ID:20616 EP_NO: N/A Repair Type: Non-Urgent Crossing Status: Found UCIP Comments: No permit identified for crossing.  Unknown use. Pipe should be removed. FIELD_STRUCT_DESC: 3-inch galvanized iron pipe through the levee 0.3 feet below the crown.  Valve on the landward shoulder. FS Date: 8/20/2013 3:28:19 PM

Pipe and vent visible on LS slope.

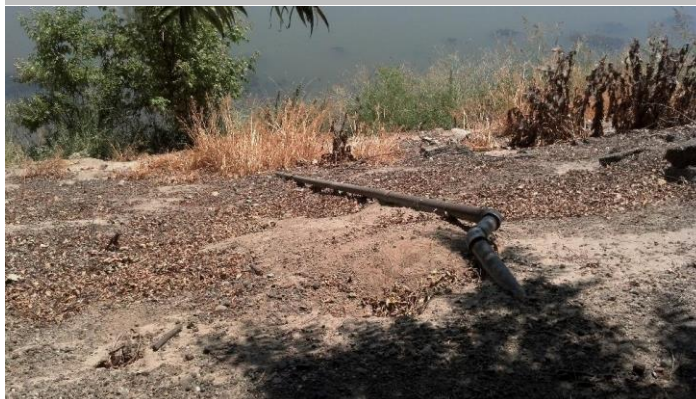
Photo 2 of 2 : UCIP\_SP\_2017\_18085\_30190.jpg

LM Start	<b>2.73</b>	Rating **	M	Issue No.	<b>951 (cont)</b>
LM End	<b>2.73</b>	Issue Type +	En	Location *	LS

Pipe visible on WS slope.

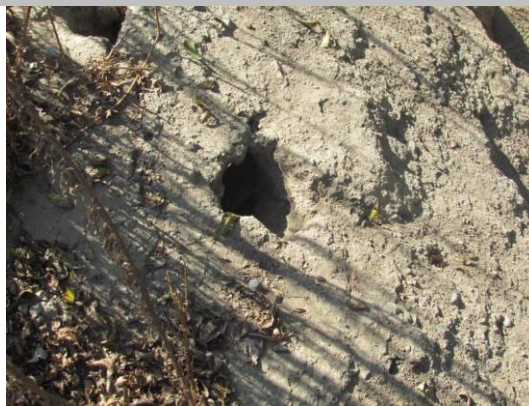
Photo 1 of 2 : SP\_2017\_RD0524\_107\_219\_20170316\_00258.jpg

LM Start	2.77	Rating **	U	Issue No.	219
LM End	2.80	Issue Type +	Ma	Location *	LS
Category	Earthen Levee			GPS Latitude/Longitude	
				Start	End
Item	Animal Control			37.915195 °	37.915052 °
				-121.322930 °	-121.323430 °
DWR ID	DWR_RD0524_01_f_2016_219				
Comment Code					
A1 : Exterminate rodents and backfill and compact or grout burrows.					
Inspector Comment					
Several large rodent holes on landward slope.

Looking at typical rodent hole on waterward slope.

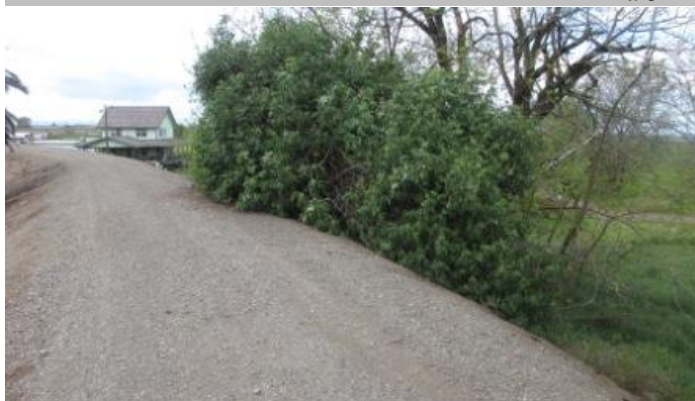
Photo 2 of 2 : SP\_2017\_RD0524\_107\_48\_20170316\_00092.jpg

LM Start	<b>2.80</b>	Rating **	U	Issue No.	<b>48 (cont)</b>
LM End	<b>2.80</b>	Issue Type +	Ma	Location *	LS

Looking south at elderberry on landside slope.(Spring 2011)

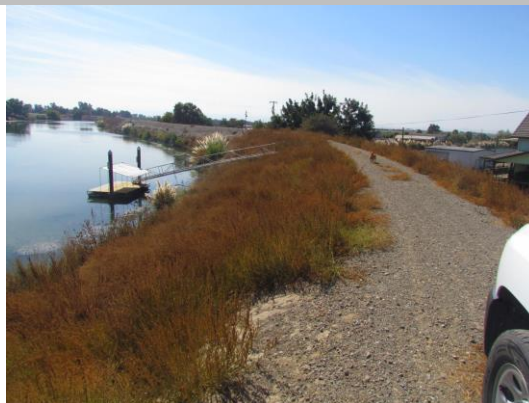
Photo 1 of 1 : SP\_2017\_RD0524\_107\_220\_20170316\_00260.jpg

LM Start	2.82	Rating **	A/W	Issue No.	220
LM End	2.87	Issue Type +	Ma	Location *	WS
Category	Earthen Levee			GPS Latitude/Longitude	
				Start	End
Item	Vegetation			37.914893 °	37.914258 °
				-121.323770 °	-121.324328 °
DWR ID	DWR_RD0524_01_f_2016_220				
Comment Code					
V1 : Control annual grass and weeds on the levee slopes and easements.					
Inspector Comment					
Dense vegetation on waterward slope.

Looking at dense veg on waterward slope.

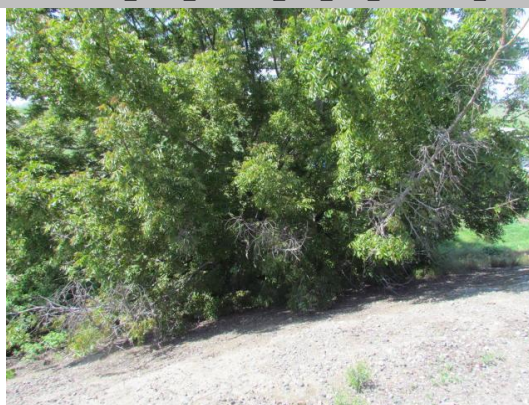
Photo 1 of 1 : SP\_2017\_RD0524\_107\_209\_20170316\_000242.jpg

LM Start	2.87	Rating **	U	Issue No.	209
LM End	2.87	Issue Type +	Ma	Location *	LS
Category	Earthen Levee			GPS Latitude/Longitude	
				Start	End
Item	Trim / Thin Trees			37.914257 °	37.914257 °
				-121.324317 °	-121.324317 °
DWR ID	DWR_RD0524_01_s_2016_209				
Comment Code					
T1 : Trim trees to at least five feet above ground level.					
Inspector Comment					
Untrimmed walnut tree on landward slope and toe.

Looking northwest at untrimmed tree at landward toe.

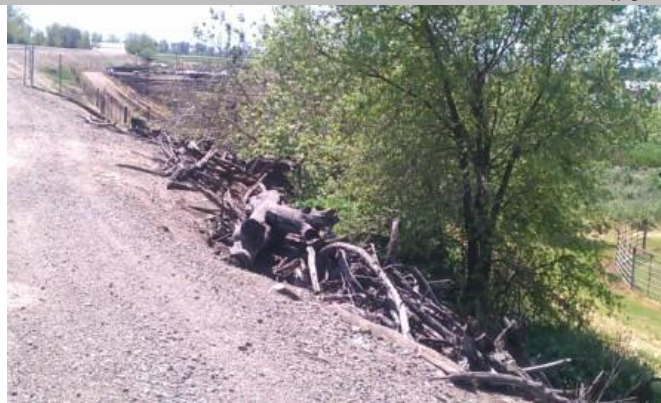
Photo 1 of 1 : SP\_2017\_RD0524\_107\_50\_20170316\_00094.jpg

LM Start	2.90	Rating **	U	Issue No.	50
LM End	2.92	Issue Type +	Ma	Location *	LS
Category	Earthen Levee			GPS Latitude/Longitude	
				Start	End
Item	Encroachments			37.913767 °	37.913503 °
				-121.324427 °	-121.324488 °
DWR ID	DWR_RD0524_01_s_2012_50				
Comment Code					
PR : Prunings					
Inspector Comment

Looking southwest at prunings on landside slope.

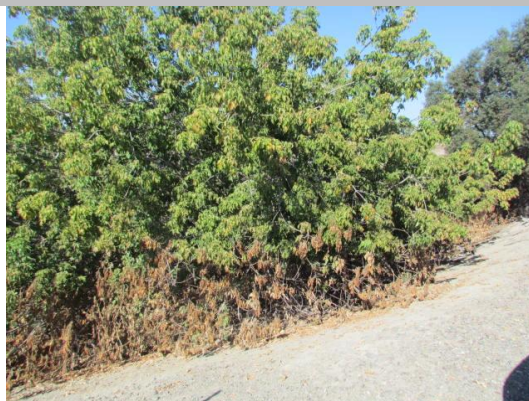
Photo 1 of 2 : SP\_2017\_RD0524\_107\_51\_20170316\_00095.jpg

LM Start	2.93	Rating **	U	Issue No.	51
LM End	2.93	Issue Type +	Ma	Location *	LS
Category	Earthen Levee			GPS Latitude/Longitude	
				Start	End
Item	Trim / Thin Trees			37.913415 °	37.913415 °
				-121.324503 °	-121.324503 °
DWR ID	DWR_RD0524_01_s_2012_51				
Comment Code					
T1 : Trim trees to at least five feet above ground level.					
Inspector Comment					
Untrimmed trees on landward slope and toe.

Looking south at dense trees on landward slope fall 2015

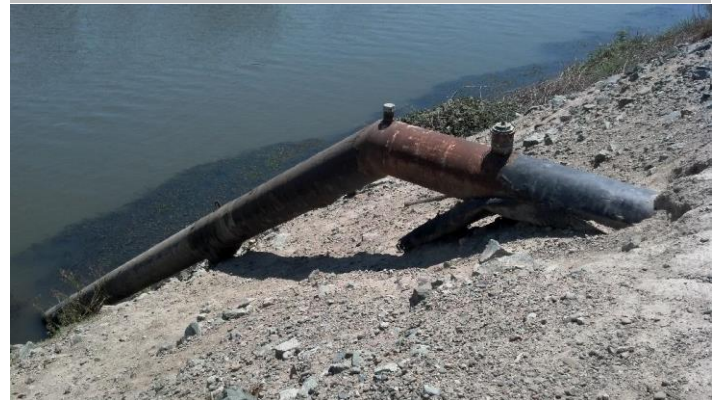
Photo 1 of 2 : UCIP\_SP\_2017\_18089\_30198.jpg

LM Start	2.95	Rating **	M	Issue No.	952
LM End	2.95	Issue Type +	En	Location *	LS
Category	Supplemental			GPS Latitude/Longitude	
				Start	End
Item	DWR UCIP Field Study			37.913101 °	37.913101 °
				-121.324500 °	-121.324500 °
DWR ID					
Comment Code					
Inspector Comment					
FS_ID:18089 DS_ID:20617 EP_NO: N/A Repair Type: Non-Urgent Crossing Status: Indicator Found UCIP Comments: Review crossing with inspector as records indicate that this should be an 8-inch pipe through levee 3.0 feet below crown, pump on landward side. Siphon breaker on the waterward slope. Originally included in the 1964 O&M manual. FIELD_STRUCT_DESC: 16-inch wrapped steel storm discharge pipe through the levee 1.5-feet below the crown. Pump on steel pile structure at drainage canal off LS toe. FS Date: 8/20/2013

PVC wrapped pipe and siphon breaker visible on WS slope.

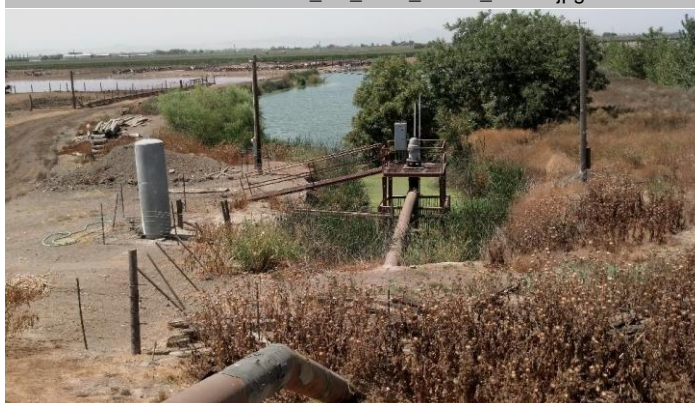
Photo 2 of 2 : UCIP\_SP\_2017\_18089\_30197.jpg

LM Start	2.95	Rating **	M	Issue No.	952 (cont)	
LM End	2.95	Issue Type +	En	Location *	LS	
Category	Supplemental			GPS Latitude/Longitude		
				Start		End
Item	DWR UCIP Field Study			37.913101 °		37.913101 °
				-121.324500 °		-121.324500 °
DWR ID						
Comment Code						
Inspector Comment						
FS_ID:18089						
DS_ID:20617						
EP_NO: N/A						
Repair Type: Non-Urgent						
Crossing Status: Indicator Found						
UCIP Comments: Review crossing with inspector as records indicate that this should be an 8-inch pipe through levee 3.0 feet below crown, pump on landward side. Siphon breaker on the waterward slope. Originally included in the 1964 O&M manual.						
FIELD_STRUCT_DESC: 16-inch wrapped steel storm discharge pipe through the levee 1.5-feet below the crown. Pump on steel pile structure at drainage canal off LS toe.						
FS Date: 8/20/2013

Pipe, pump, power pole, and meter visible off LS toe.

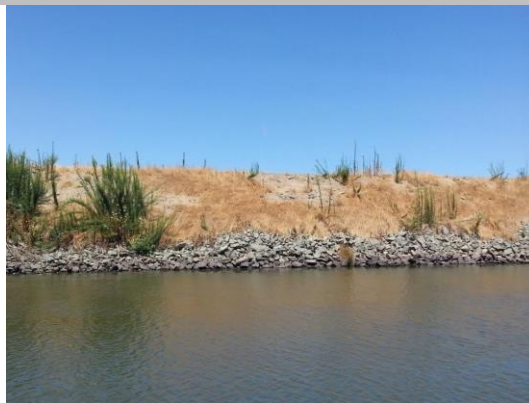
Photo 2 of 2 : SP\_2017\_RD0524\_107\_126\_20170316\_00185.jpg

LM Start	2.96	Rating **	U	Issue No.	126 (cont)
LM End	2.96	Issue Type +	Ma	Location *	WS
Category	Supplemental			GPS Latitude/Longitude	
				Start	End
Item	DWR Erosion Survey			37.913010 °	37.913010 °
				-121.324490 °	-121.324490 °
DWR ID	DWR_RD0524_01_s_2017_126				
Comment Code					
Inspector Comment					
07/25/2016: No significant change observed.					
06/24/2015: No significant change observed.					
06/19/2014: No significant change observed.					
08/13/2013: No significant change observed.					
08/07/2012: The site was first reported in 2012 spring levee inspection report. [2016 Site ID:RD0524U01RM43.52]

Close view of the erosion. Note the vegetation at the site.

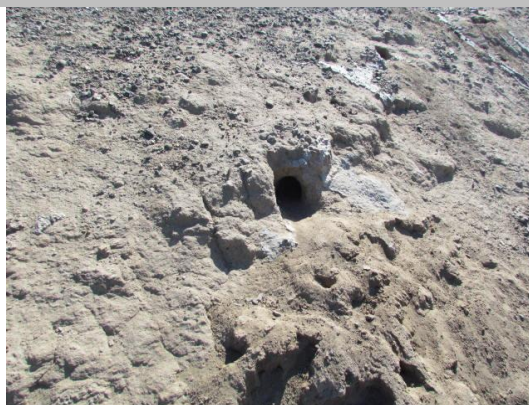
Photo 1 of 2 : SP\_2017\_RD0524\_107\_925\_20170316\_00279.jpg

LM Start	3.07	Rating **	M	Issue No.	925
LM End	3.27	Issue Type +	Ma	Location *	LS
Category	Earthen Levee			GPS Latitude/Longitude	
				Start	End
Item	Animal Control			37.911382 °	37.908602 °
				-121.324928 °	-121.325395 °
DWR ID	DWR_RD0524_01_s_2012_925				
Comment Code					
A1 : Exterminate rodents and backfill and compact or grout burrows.					
Inspector Comment					
Several rodent holes on levee slopes.

Looking at typical view of rodent hole with this section fall 2015.

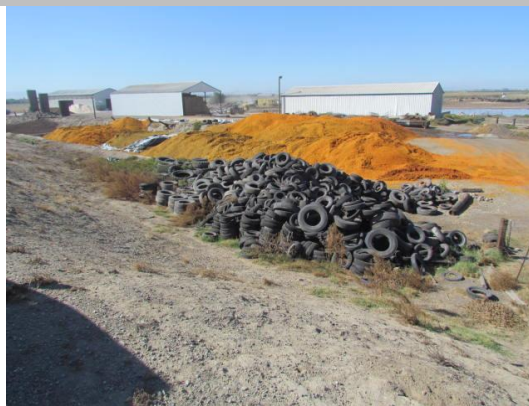
Photo 1 of 1 : SP\_2017\_RD0524\_107\_169\_20170316\_00196.jpg

LM Start	3.10	Rating **	U	Issue No.	169
LM End	3.10	Issue Type +	En	Location *	LS
Category	Earthen Levee			GPS Latitude/Longitude	
				Start	End
Item	Encroachments			37.911070 °	37.911070 °
				-121.325090 °	-121.325090 °
DWR ID	DWR_RD0524_01_f_2015_169				
Comment Code					
GA : Garbage					
Inspector Comment					
Rubber tire stockpile at landward toe.

Looking west at rubber tires at landward toe.

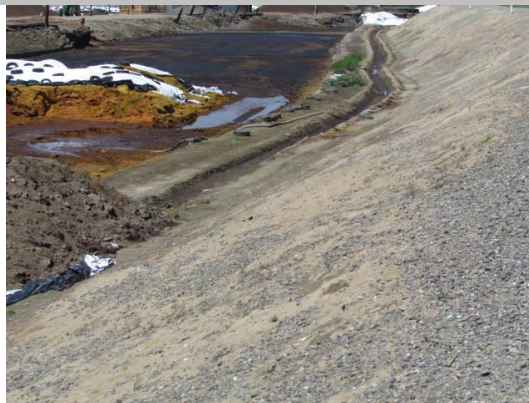
Photo 1 of 2 : SP\_2017\_RD0524\_107\_212\_20170316\_00245.jpg

LM Start	3.11	Rating **	M	Issue No.	212
LM End	3.27	Issue Type +	En	Location *	LS
Category	Earthen Levee			GPS Latitude/Longitude	
				Start	End
Item	Encroachments			37.910876 °	37.908558 °
				-121.325181 °	-121.325394 °
DWR ID	DWR_RD0524_01_s_2016_212				
Comment Code					
DT : Ditch					
Inspector Comment					
Shallow drainage ditch at landward toe.

Looking northwest at southend of ditch at landward toe.

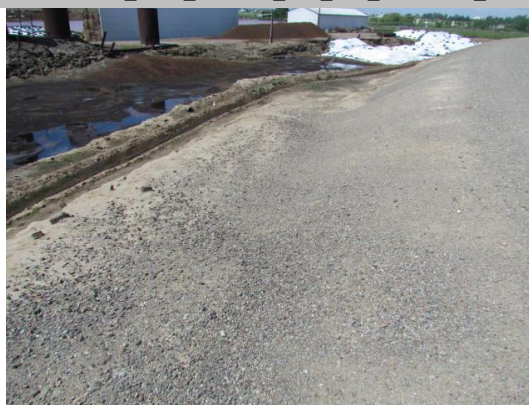
Photo 1 of 1 : SP\_2017\_RD0524\_107\_211\_20170316\_00244.jpg

LM Start	3.18	Rating **	U	Issue No.	211
LM End	3.18	Issue Type +	En	Location *	LS
Category	Earthen Levee			GPS Latitude/Longitude	
				Start	End
Item	Encroachments			37.909945 °	37.909945 °
				-121.325543 °	-121.325543 °
DWR ID	DWR_RD0524_01_s_2016_211				
Comment Code					
RA : Ramp					
Inspector Comment					
Unauthorized ramp on landward slope.

Looking northwest at unauthorized ramp on landward slope.

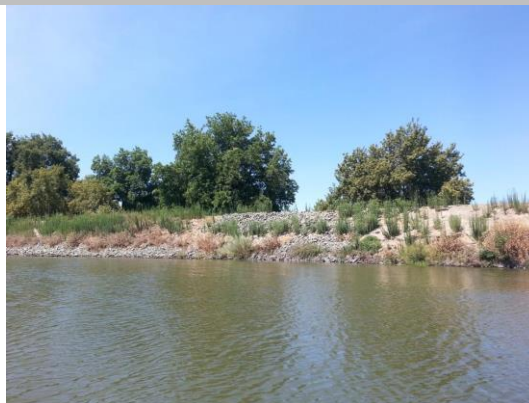
Photo 1 of 1 : SP\_2017\_RD0524\_107\_129\_20170316\_00186.jpg

LM Start	3.30	Rating **	U	Issue No.	129
LM End	3.32	Issue Type +	Ma	Location *	WS
Category	Supplemental			GPS Latitude/Longitude	
				Start	End
Item	DWR Erosion Survey			37.908090 °	37.908090 °
				-121.325090 °	-121.325090 °
DWR ID	DWR_RD0524_01_s_2017_129				
Comment Code					
Inspector Comment					
07/25/2016: No significant change observed.					
06/24/2015: No significant change observed.					
06/19/2014: No significant change observed.					
08/13/2013: The levee toe seems to have been protected by river rocks and vegetation on site. [2016 Site ID:RD0524U01RM43.86]

Close view of the erosion. Note the river rocks and vegetation at the levee toe.

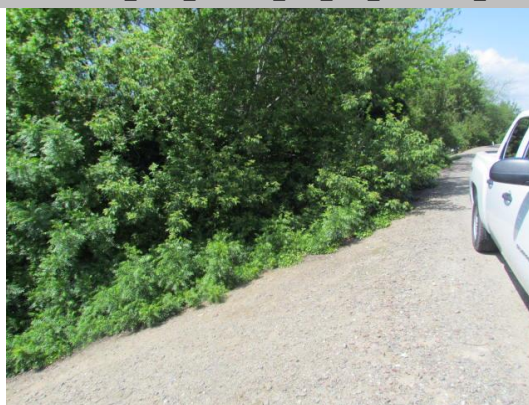
Photo 1 of 2 : SP\_2017\_RD0524\_107\_926\_20170316\_00281.jpg

LM Start	3.30	Rating **	U	Issue No.	926
LM End	3.38	Issue Type +	Ma	Location *	LS
Category	Earthen Levee			GPS Latitude/Longitude	
				Start	End
Item	Trim / Thin Trees			37.908158 °	37.907080 °
				-121.325418 °	-121.325366 °
DWR ID	DWR_RD0524_01_s_2012_926				
Comment Code					
T1 : Trim trees to at least five feet above ground level.					
Inspector Comment

Looking southwest at dense veg on landward slope.

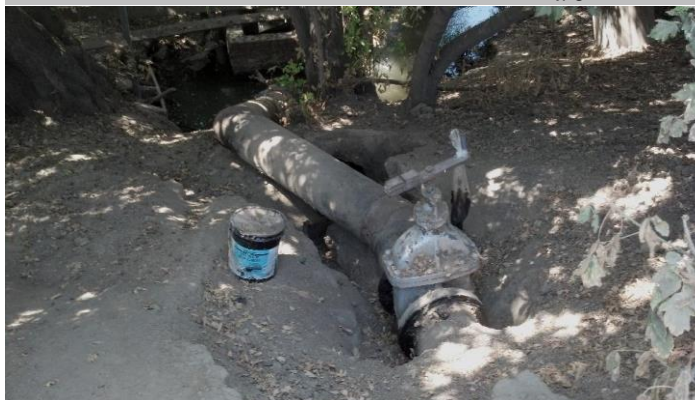
Photo 2 of 3 : UCIP\_SP\_2017\_51320\_30205.jpg

FS\_ID:51320  
DS\_ID:20618  
EP\_NO: N/A  
Repair Type: Urgent  
Crossing Status: Found  
UCIP Comments: 11/16/2016 same as previous inspection erosion is still present on LS toe and slope. Owner will need to coordinate with CVFPB to address erosion issue on LS toe. (O. Magana - DWR UCIP)08/20/2013 Extensive erosion on LS toe at distribution box due to failure of box/pipe connection. Erosion on LS slope do to recently repaired leak at gate valve. (W. Wylie - DWR UCIP)  
FIELD\_STRUCT\_DESC: 14-inch steel irrigation pipe (O&M reference list 12-inch pipe) through the levee, 7 feet below the crown. Pump house is located on the waterside (WS) slope. Gate valve is located on the landside (LS) slope. A 4-foot by 4-foot brick distribution box built in 1918 is located on the LS toe. This site was use to manufacture brick back in 1918 and some of the appurtenances that remain are still in use (distribution box and ditch). [Additional Reference(s): DWR Levee Log, 2004. USACE San Joaquin River O&M Unit 7, April 1964, (HLM 3.38). conversation with owner 2016].

LM Start	<b>3.35</b>	Rating **	U	Issue No.	<b>953 (cont)</b>
LM End	<b>3.35</b>	Issue Type +	En	Location *	WS

Pipe, gatevalve, and erosion on LS slope.

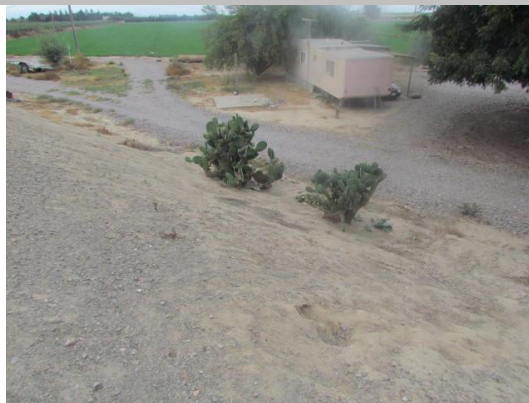
Photo 1 of 1 : SP\_2017\_RD0524\_107\_124\_20170316\_00183.jpg

LM Start	3.61	Rating **	M	Issue No.	124
LM End	3.61	Issue Type +	En	Location *	LS
Category	Earthen Levee			GPS Latitude/Longitude	
				Start	End
Item	Vegetation			37.904375 °	37.904375 °
				-121.324615 °	-121.324615 °
DWR ID	DWR_RD0524_01_f_2012_124				
Comment Code					
V6 : Landscaping					
Inspector Comment					
Landowner planted cactus on landside toe.

Looking west at cactus on landside toe.

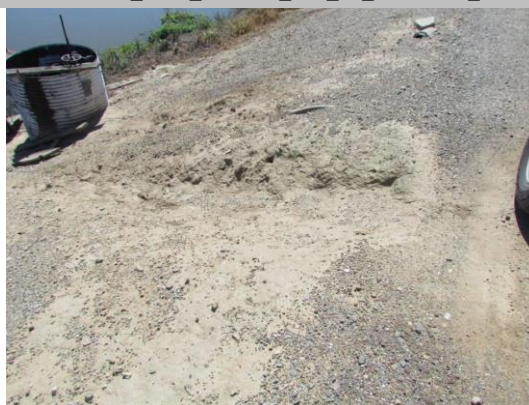
Photo 1 of 2 : SP\_2017\_RD0524\_107\_58\_20170407\_00389.jpg

LM Start	3.64	Rating **	M	Issue No.	58
LM End	3.64	Issue Type +	Ma	Location *	WS
Category	Earthen Levee			GPS Latitude/Longitude	
				Start	End
Item	Slope Stability			37.904113 °	37.904113 °
				-121.325080 °	-121.325080 °
DWR ID	DWR_RD0524_01_s_2012_58				
Comment Code					
S2 : Repair the levee slope damaged by foot traffic and prevent access where possible.					
Inspector Comment					
Landowner cut steps into waterside slope.					
4/3/17: Steps washed away slope damage remains.

Looking south at step cut into waterward slope. (Spring 2017)

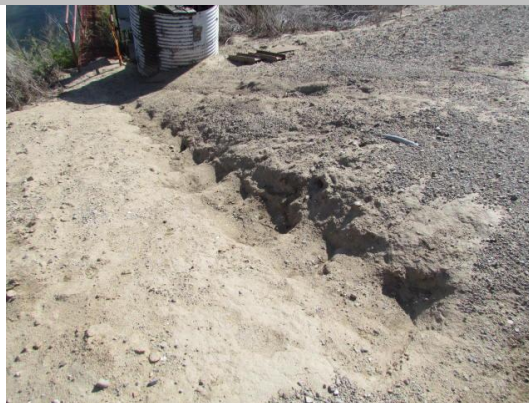
Photo 2 of 2 : SP\_2017\_RD0524\_107\_58\_20170316\_00103.jpg

LM Start	<b>3.64</b>	Rating **	M	Issue No.	<b>58 (cont)</b>
LM End	<b>3.64</b>	Issue Type +	Ma	Location *	WS

Looking southeast steps cut into waterside slope.

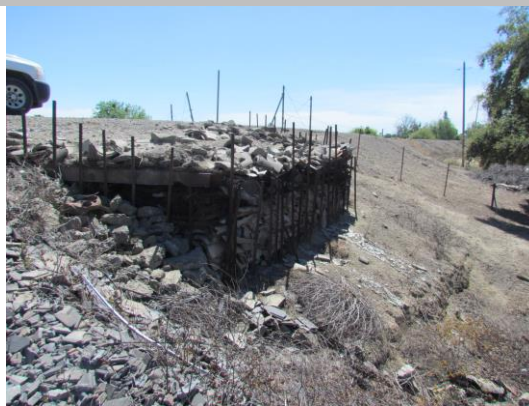
Photo 1 of 1 : SP\_2017\_RD0524\_107\_164\_20170407\_00390.jpg

LM Start	3.66	Rating **	U	Issue No.	164
LM End	3.66	Issue Type +	En	Location *	LS
Category	Earthen Levee			GPS Latitude/Longitude	
				Start	End
Item	Encroachments			37.903983 °	37.903983 °
				-121.325198 °	-121.325198 °
DWR ID	DWR_RD0524_01_s_2017_164				
Comment Code					
BU : Building					
Inspector Comment					
abandoned deck on landside shoulder.

Looking south at abandoned deck on landward shoulder and slope.

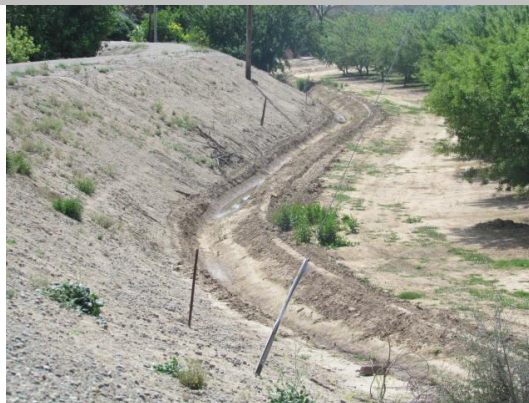
Photo 1 of 2 : SP\_2017\_RD0524\_107\_194\_20170316\_00224.jpg

LM Start	3.69	Rating **	U	Issue No.	194
LM End	3.78	Issue Type +	En	Location *	LS
Category	Earthen Levee			GPS Latitude/Longitude	
				Start	End
Item	Encroachments			37.903553 °	37.902505 °
				-121.325468 °	-121.326425 °
DWR ID	DWR_RD0524_01_s_2015_194				
Comment Code					
DT : Ditch					
Inspector Comment					
Shallow Irrigation ditch at landward toe.

Looking south at irrigation ditch at landward toe.

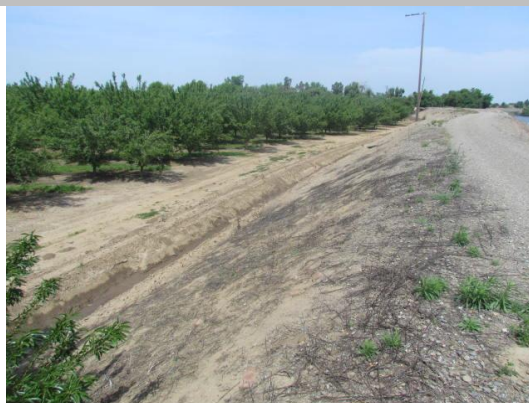
Photo 2 of 2 : SP\_2017\_RD0524\_107\_194\_20170316\_00225.jpg

Looking east at south end of irrigation ditch at landward toe.

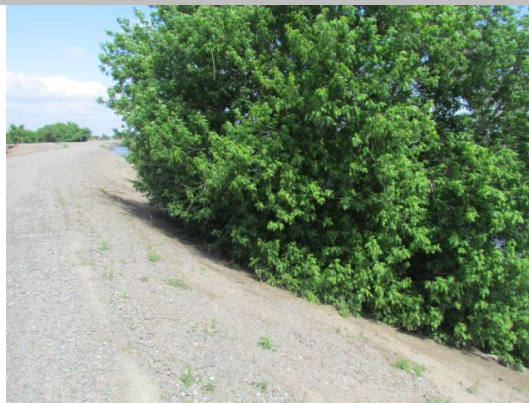
Photo 1 of 1 : SP\_2017\_RD0524\_107\_52\_20170316\_00097.jpg

LM Start	3.75	Rating **	U	Issue No.	52
LM End	3.75	Issue Type +	Ma	Location *	WS
Category	Earthen Levee			GPS Latitude/Longitude	
				Start	End
Item	Trim / Thin Trees			37.902828 °	37.902828 °
				-121.326170 °	-121.326170 °
DWR ID	DWR_RD0524_01_s_2016_52				
Comment Code					
T1 : Trim trees to at least five feet above ground level.					
Inspector Comment

Looking south at untrimmed tree on landward slope and toe.

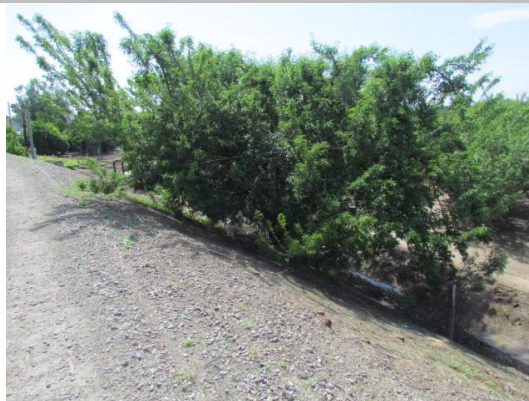
Photo 1 of 1 : SP\_2017\_RD0524\_107\_927\_20170316\_00283.jpg

LM Start	3.77	Rating **	U	Issue No.	927
LM End	3.77	Issue Type +	Ma	Location *	LS
Category	Earthen Levee			GPS Latitude/Longitude	
				Start	End
Item	Trim / Thin Trees			37.902645 °	37.902645 °
				-121.326340 °	-121.326340 °
DWR ID	DWR_RD0524_01_s_2012_927				
Comment Code					
T1 : Trim trees to at least five feet above ground level.					
Inspector Comment					
Untrimmed almond tree on landward slope.

Looking southwest at untrimmed tree at landward toe.

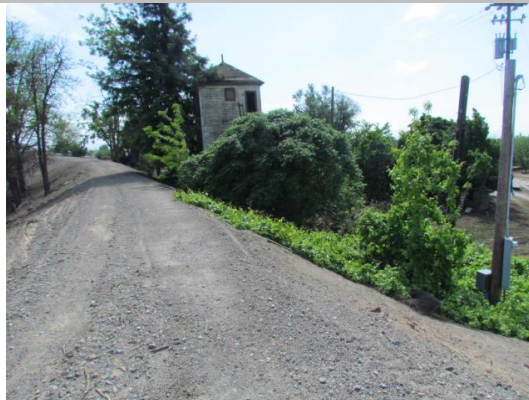
Photo 1 of 1 : SP\_2017\_RD0524\_107\_59\_20170316\_00104.jpg

LM Start	3.78	Rating **	U	Issue No.	59
LM End	3.78	Issue Type +	Ma	Location *	LS
Category	Earthen Levee			GPS Latitude/Longitude	
				Start	End
Item	Trim / Thin Trees			37.902417 °	37.902417 °
				-121.326482 °	-121.326482 °
DWR ID	DWR_RD0524_01_s_2012_59				
Comment Code					
T1 : Trim trees to at least five feet above ground level.					
Inspector Comment

Looking south at dense veg on landward slope and toe.

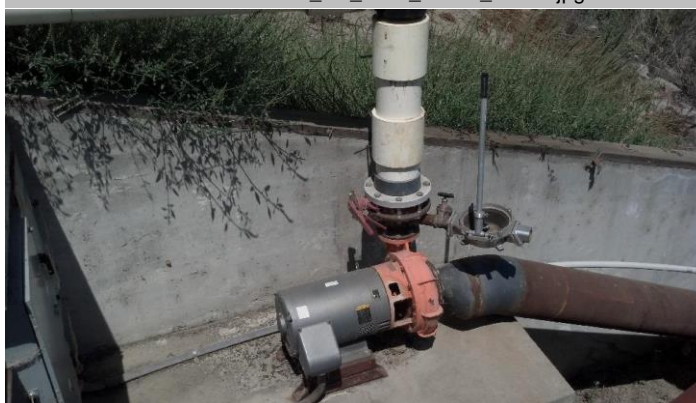
Photo 1 of 3 : UCIP\_SP\_2017\_22725\_38445.jpg

LM Start	3.79	Rating **	M	Issue No.	954
LM End	3.79	Issue Type +	En	Location *	LS
Category	Supplemental			GPS Latitude/Longitude	
				Start	End
Item	DWR UCIP Field Study			37.902371 °	37.902371 °
				-121.326440 °	-121.326440 °
DWR ID					
Comment Code					
Inspector Comment					
FS_ID:22725					
DS_ID:24044					
EP_NO: N/A					
Repair Type: Non-Urgent					
Crossing Status: Found					
UCIP Comments: No permit identified for this crossing.					
FIELD_STRUCT_DESC: 8-inch steel irrigation pipe through the levee 0-					
feet below the crown. Pipe integrated into steel cattelguard style					
crossing. Slant pump and butterfly valve at concrete foundation on WS					
slope. Filter plant, vents, and butterfly valves on LS toe.					
FS Date: 8/20/2013

Pump and butterfly valve on concrete pad on WS shoulder.

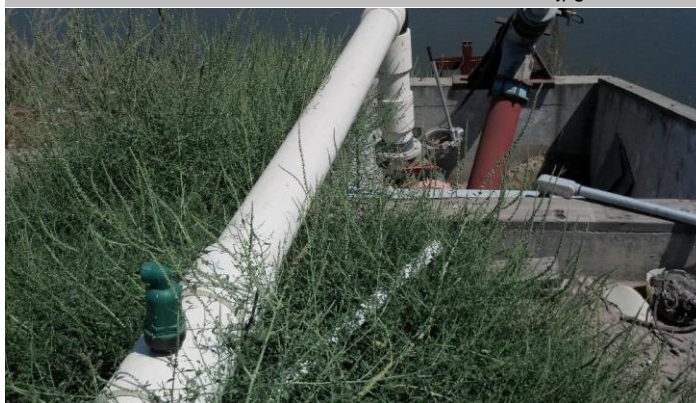
Photo 2 of 3 : UCIP\_SP\_2017\_22725\_38444.jpg

Vent on PVC pipe at WS shoulder.

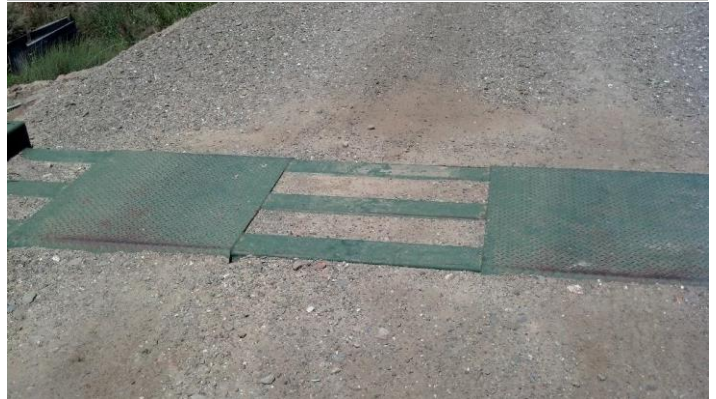
Photo 3 of 3 : UCIP\_SP\_2017\_22725\_38443.jpg

LM Start	3.79	Rating **	M	Issue No.	954 (cont)
LM End	3.79	Issue Type +	En	Location *	LS
Category	Supplemental			GPS Latitude/Longitude	
				Start	End
Item	DWR UCIP Field Study			37.902371 °	37.902371 °
				-121.326440 °	-121.326440 °
DWR ID					
Comment Code					
Inspector Comment					
FS_ID:22725 DS_ID:24044 EP_NO: N/A Repair Type: Non-Urgent Crossing Status: Found UCIP Comments: No permit identified for this crossing. FIELD_STRUCT_DESC: 8-inch steel irrigation pipe through the levee 0-feet below the crown. Pipe integrated into steel cattelguard style crossing. Slant pump and butterfly valve at concrete foundation on WS slope. Filter plant, vents, and butterfly valves on LS toe. FS Date: 8/20/2013

Steel, integrated cattelguard style pipe crossing at crown elevation.

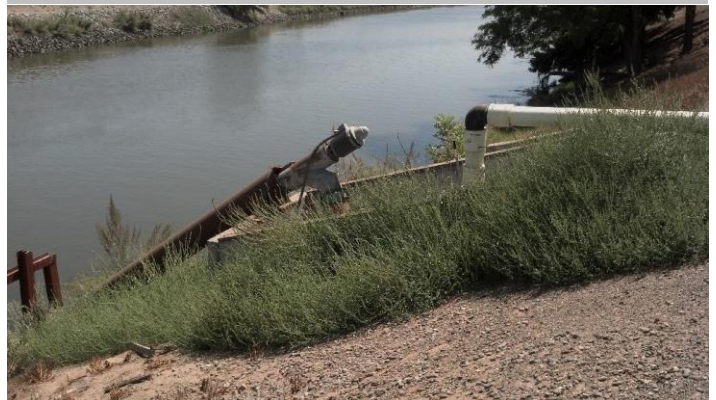
Photo 1 of 3 : UCIP\_SP\_2017\_18307\_30528.jpg

LM Start	3.79	Rating **	M	Issue No.	955
LM End	3.79	Issue Type +	En	Location *	LS
Category	Supplemental			GPS Latitude/Longitude	
				Start	End
Item	DWR UCIP Field Study			37.902361 °	37.902361 °
				-121.326443 °	-121.326443 °
DWR ID					
Comment Code					
Inspector Comment					
FS_ID:18307 DS_ID:20620 EP_NO: N/A Repair Type: Non-Urgent Crossing Status: Found UCIP Comments: Appears abandoned and if so should be done so properly. Evidence of severe internal corrosion in concrete distribution box at LS toe. FIELD_STRUCT_DESC: 12-inch concrete encased pipe through the levee 10.5 feet below the crown, pump and gate valve in pump house on the waterward slope. 6'X6' Concrete distribution box on the landward toe. Two concrete cutoff walls. Service pole at the landward toe. Originally included in the 1964 O&M manual. FS Date: 8/20/2013

Slant pump visible at concrete foundation on WS slope. Pumphouse removed.

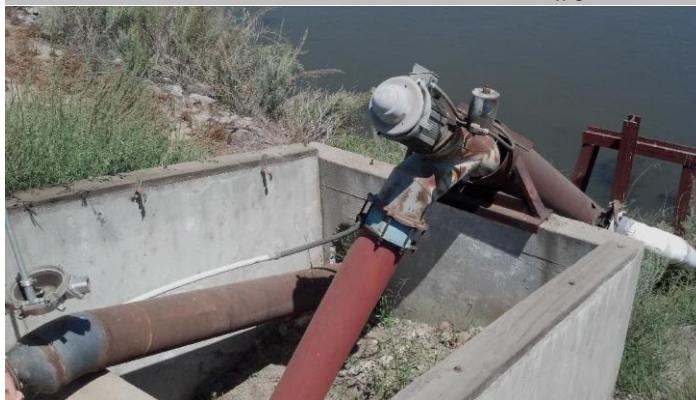
Photo 2 of 3 : UCIP\_SP\_2017\_18307\_30527.jpg

Slant pump and pipe on WS slope.

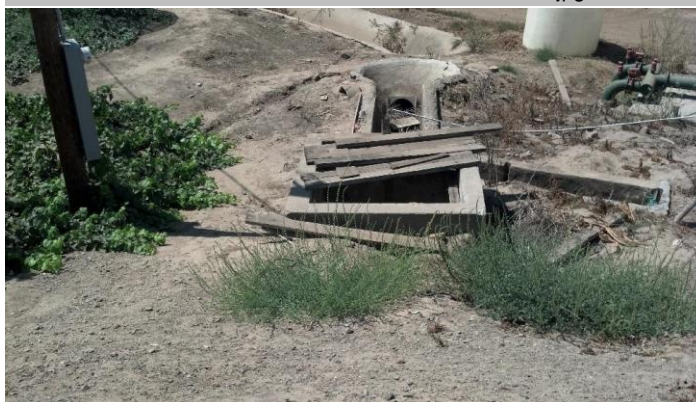
Photo 3 of 3 : UCIP\_SP\_2017\_18307\_30526.jpg

6'X6' concrete distribution box and power pole on LS toe.

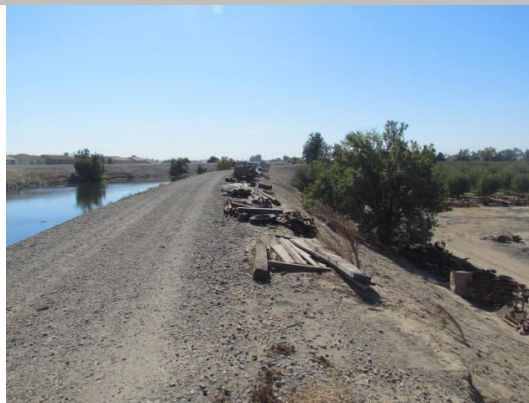
Photo 1 of 3 : SP\_2017\_RD0524\_107\_95\_20170316\_00154.jpg

LM Start	3.87	Rating **	U	Issue No.	95
LM End	3.97	Issue Type +	En	Location *	LS
Category	Earthen Levee			GPS Latitude/Longitude	
				Start	End
Item	Encroachments			37.901147 °	37.899750 °
				-121.326453 °	-121.326598 °
DWR ID	DWR_RD0524_01_f_2013_95				
Comment Code					
EQ : Equipment					
Inspector Comment					
Landowner is storing equipment on landward shoulder and landward toe.

Looking south at farm equipment stored on landward shoulder and toe.

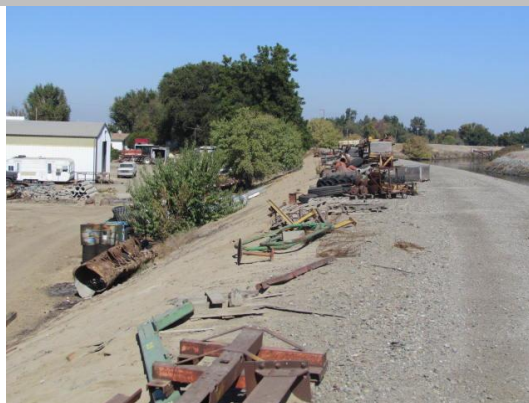
Photo 2 of 3 : SP\_2017\_RD0524\_107\_95\_20170316\_00155.jpg

Looking north at farm equipment stored on landward shoulder.

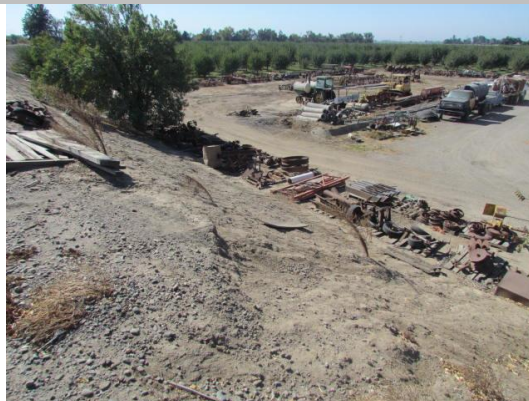
Photo 3 of 3 : SP\_2017\_RD0524\_107\_95\_20170316\_00156.jpg

Looking west at farm equipment stored at landward toe.

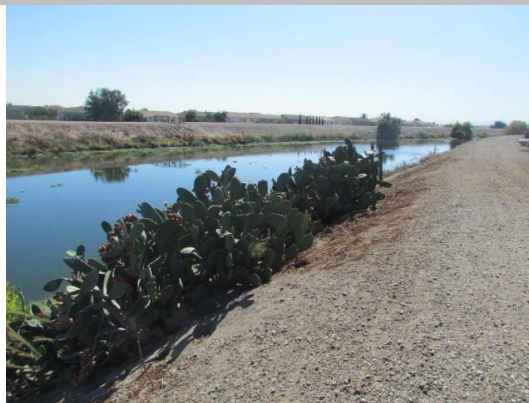
Photo 1 of 2 : SP\_2017\_RD0524\_107\_94\_20170316\_00152.jpg

LM Start	3.88	Rating **	U	Issue No.	94
LM End	3.88	Issue Type +	Ma	Location *	WS
Category	Earthen Levee			GPS Latitude/Longitude	
				Start	End
Item	Vegetation			37.900952 °	37.900952 °
				-121.326443 °	-121.326443 °
DWR ID	DWR_RD0524_01_s_2012_94				
Comment Code					
V2 : Remove the wild growth other than native grasses from the levee slopes.					
Inspector Comment					
Remove cactus from waterward slope.

Looking southeast at cactus on waterward slope fall 2015

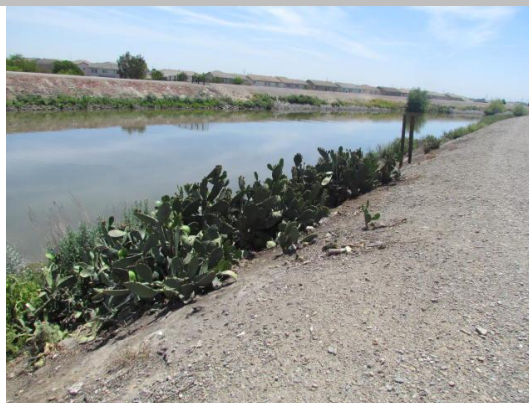
Photo 2 of 2 : SP\_2017\_RD0524\_107\_94\_20170316\_00153.jpg

Looking southeast at cactus on waterside slope. Fall 2013

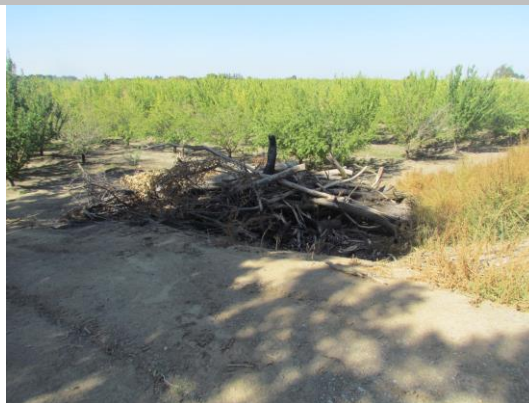
Photo 1 of 2 : SP\_2017\_RD0524\_107\_195\_20170316\_00226.jpg

LM Start	4.02	Rating **	U	Issue No.	195
LM End	4.02	Issue Type +	En	Location *	LS
Category	Earthen Levee			GPS Latitude/Longitude	
				Start	End
Item	Encroachments			37.899093 °	37.899093 °
				-121.326933 °	-121.326933 °
DWR ID	DWR_RD0524_01_s_2015_195				
Comment Code					
PR : Prunings					
Inspector Comment					
Pruning pile blocking view of landward slope.

Looking southwes at large pruning pile at landward toe. (Fall 2016)

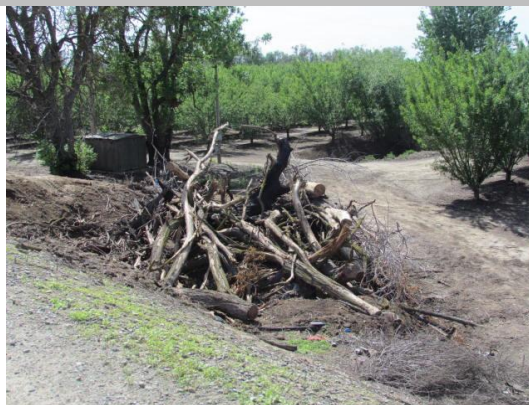
Photo 2 of 2 : SP\_2017\_RD0524\_107\_195\_20170316\_00227.jpg

Looking at pruning pile at landward toe. (Spring 2016)

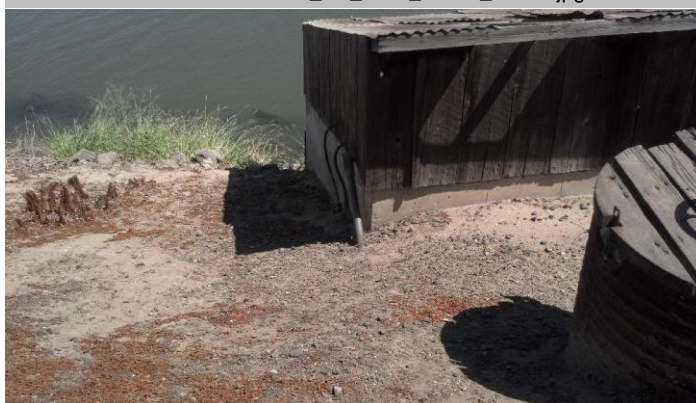
Photo 1 of 3 : UCIP\_SP\_2017\_18314\_30559.jpg

LM Start	4.04	Rating **	M	Issue No.	957
LM End	4.04	Issue Type +	En	Location *	LS
Category	Supplemental			GPS Latitude/Longitude	
				Start	End
Item	DWR UCIP Field Study			37.898853 °	37.898853 °
				-121.327049 °	-121.327049 °
DWR ID					
Comment Code					
Inspector Comment					
FS_ID:18314 DS_ID:20623 EP_NO: N/A Repair Type: Non-Urgent Crossing Status: Found UCIP Comments: Appears abandoned and if so should be done so properly. FIELD_STRUCT_DESC: 8-inch concrete encased pipe through the levee 9.5-feet below crown, pump and gate valve in pump house on the waterward slope. Slide gate in 42-inch corrugated metal pipe riser on the waterward slope. Brick standpipe at the toe of the landward slope. 1.5-inch galvanized iron electrical conduit through the levee 3-feet below the crown at the same location. Originally included in the 1964 O&M manual. FS Date: 8/20/2013

Electrical conduit visible on WS slope at pumphouse.

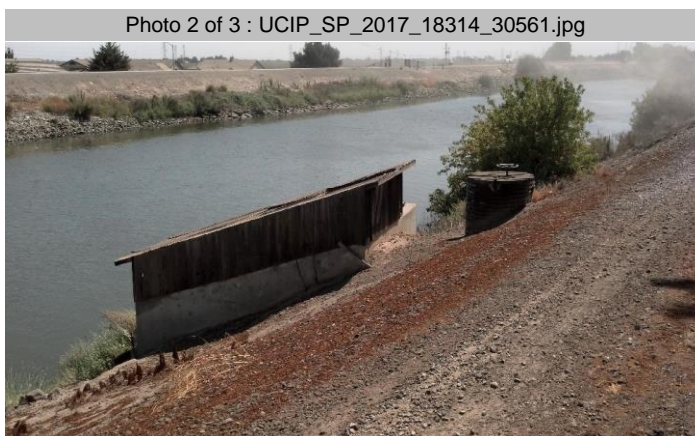
Pumphouse and gate valve in CMP riser on WS slope.

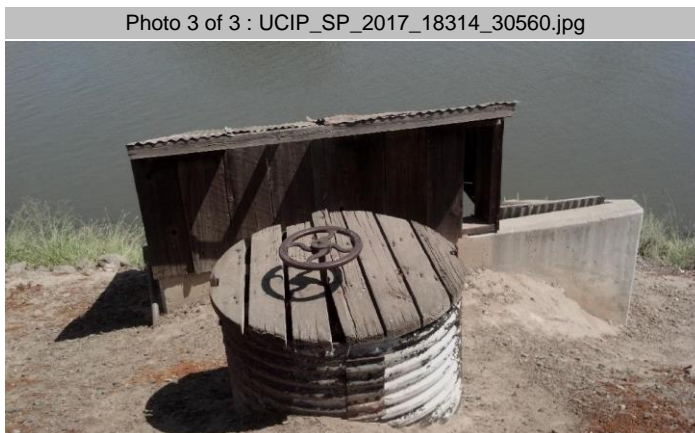
Pumphouse and gate valve in CMP riser on WS slope.

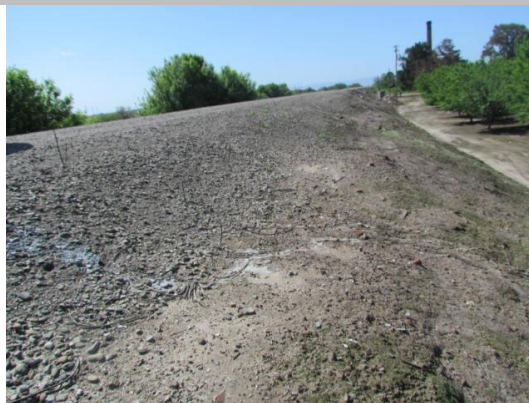
Photo 1 of 3 : SP\_2017\_RD0524\_107\_108\_20170316\_00166.jpg

LM Start	4.10	Rating **	U	Issue No.	108
LM End	4.15	Issue Type +	Ma	Location *	LS
Category	Earthen Levee			GPS Latitude/Longitude	
				Start	End
Item	Slope Stability			37.898035 °	°
				-121.327447 °	-121.327806 °
DWR ID	DWR_RD0524_01_s_2012_108				
Comment Code					
S1 : Repair slope instability.					
Inspector Comment					
Slope depression is greater than 1" and longer than 200'.

Looking north at caving slope on landside of levee.

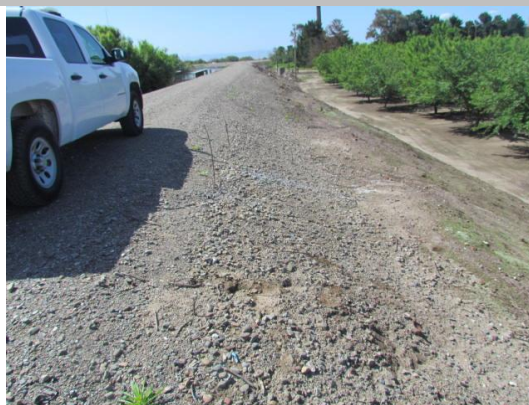
Photo 2 of 3 : SP\_2017\_RD0524\_107\_108\_20170316\_00167.jpg

Looking south at damage slope on landside of levee.

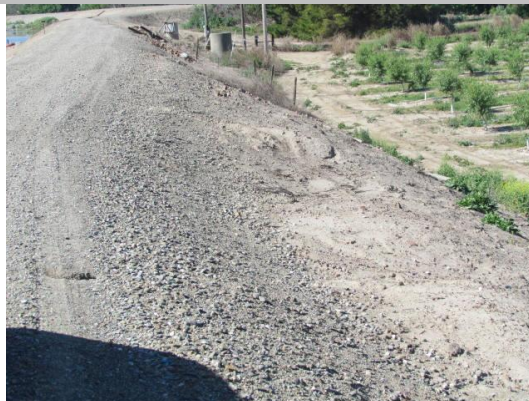
Photo 3 of 3 : SP\_2017\_RD0524\_107\_108\_20170316\_00168.jpg

Looking southwest at caving slope on landside of levee. (Spring 2014)

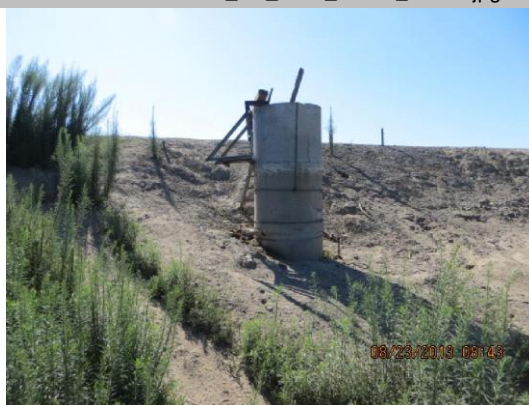
Photo 1 of 3 : UCIP\_SP\_2017\_18318\_30589.jpg

LM Start	4.16	Rating **	M	Issue No.	958
LM End	4.16	Issue Type +	En	Location *	LS
Category	Supplemental			GPS Latitude/Longitude	
				Start	End
Item	DWR UCIP Field Study			37.897118 °	37.897118 °
				-121.327910 °	-121.327910 °
DWR ID					
Comment Code					
Inspector Comment					
FS_ID:18318					
DS_ID:20625					
EP_NO: N/A					
Repair Type: Non-Urgent					
Crossing Status: Found					
UCIP Comments: Small leak on WS slope causing minor erosion on WS slope.					
FIELD_STRUCT_DESC: 12-inch steel irrigation pipe through the levee 4.5 feet below the crown, pumphouse and gate valve on the waterward slope. 36-inch concrete standpipe, power pole, and meter on LS toe. Originally included in the 1964 O&M manual.					
FS Date: 8/23/2013

Concrete standpipe on LS slope.

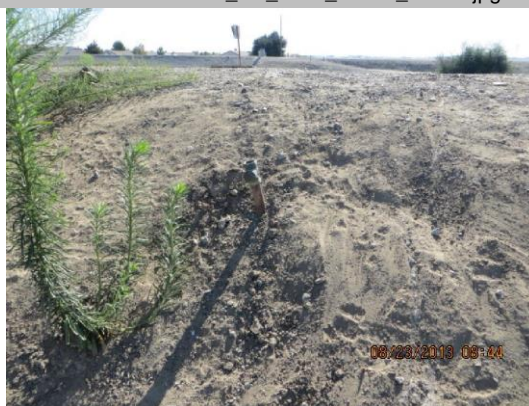
Photo 2 of 3 : UCIP\_SP\_2017\_18318\_30588.jpg

Vent or siphon breaker just off LS shoulder.

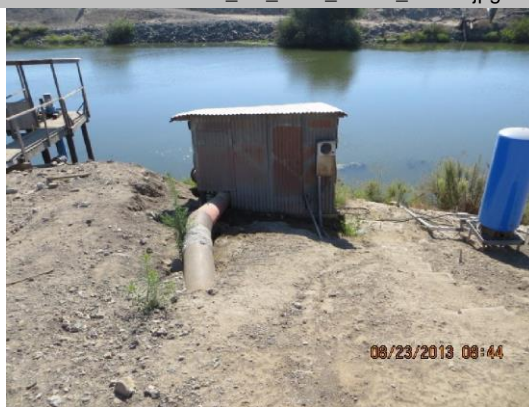
Photo 3 of 3 : UCIP\_SP\_2017\_18318\_30587.jpg

Pumphouse and pipe on WS slope.
